Hardware Product Change Notice

Hardware version: 2.00

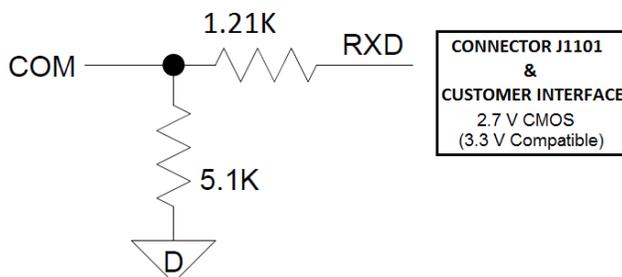
1. The temperature sensor IC used on OEM615 rev 1.01 was EOLed. A PCB spin was required to implement a new version of the temperature sensor from the same manufacturer. There is no system performance impact due to this change.
2. With the PCB spin already required for the above change, NovAtel chose to implement a second minor HW change. To eliminate a remote, but still possible, chance of overdriving the COM inputs to the OEM card, a minor change was made on all LVTTTL communication ports (RXD of COM1, 2 and 3). This involved adding two resistors to each OEM615 RXD line as follows:

The integrator should ensure that the circuit implemented on their side does not have a pull up resistor to 3.3V or other voltage level, since this will cause the signal to be degraded as a resistive splitter will be created.
